RESOLUTION NO. 20-2024

Resolution Declaring the Structures at 9023 Cincinnati-Dayton Road, West Chester, Ohio 45069, and 9031 Cincinnati-Dayton Road, West Chester, Ohio 45069, to be Unsafe and/or Structurally Defective and Ordering Such Structures Removed

Interoffice Memorandum

Re: Property Located at 9023 Cincinnati-Dayton Road

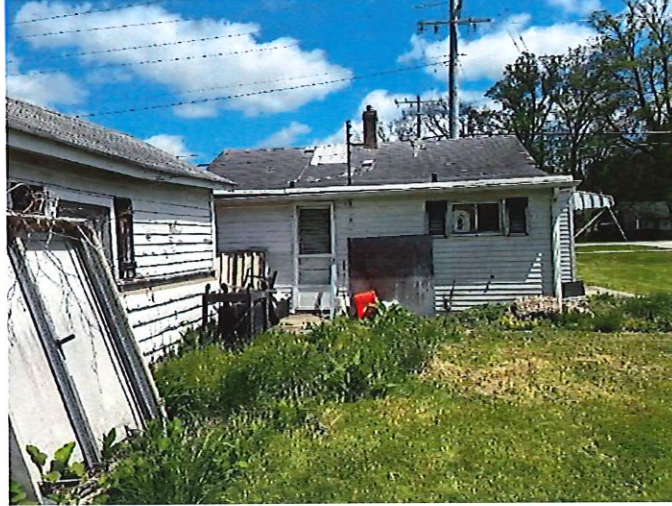
Figure 2
Rear view of 9023 Cincinnati-Dayton Road

As of the date of this report, the single-family home remains in a state of disrepair due to the severity of the fire damage. The structural integrity of the building has been compromised, with sections of the walls severely weakened. Interior spaces have suffered extensive heat and smoke damage, rendering them uninhabitable.

It is the recommendation that the single-family home at 9023 Cincinnati-Dayton Road be considered for demolition to mitigate any unauthorized entries, injuries or any additional situations not noted in this report.

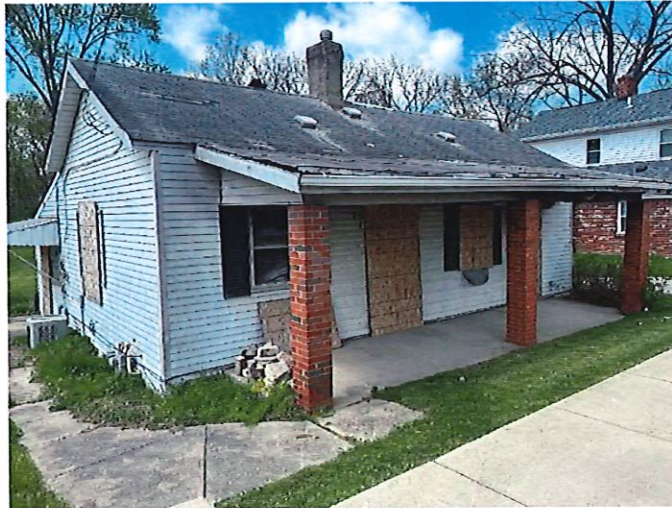
Figure 3
Street view of 9023 Cincinnati-Dayton Road

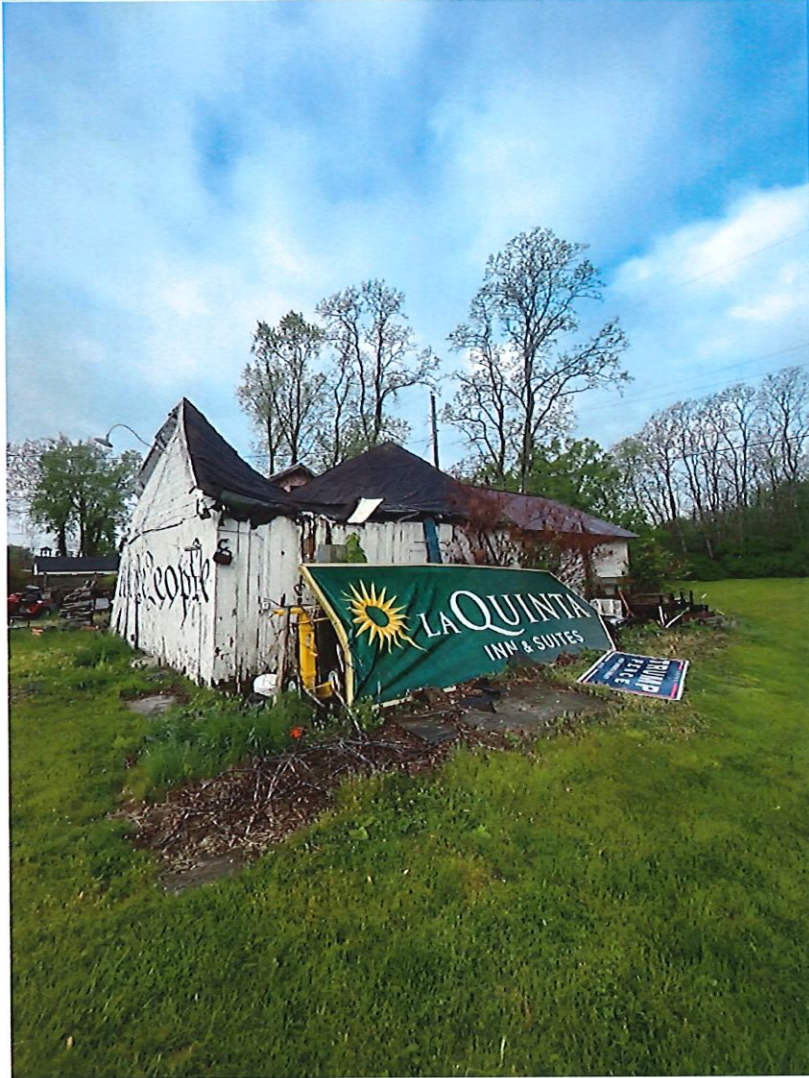
Figure 4

Other Considerations: On the adjacent property (9031 Cincinnati-Dayton Road), also owned by the owner of the property located at 9023 Cincinnati-Dayton Road, is an ancillary garage structure that currently shows conditions of structural integrity compromise. The roof has collapsed in on itself creating a public safety concern for anyone in or around the structure. It will be the recommendation of the Loss Prevention Bureau that no persons be permitted to enter the garage for any reason. The garage was not involved with the fire that occurred on December 16, 2022 but poses enough of a public safety risk that the demolition of this structure also be considered.

Garage located at 9031 Cincinnati-Dayton Road

It is also the recommendation that due to the structural conditions of the barn located on the adjacent parcel and also owned by the same person, the barn be demolished as it is a danger to both authorized and unauthorized entry.

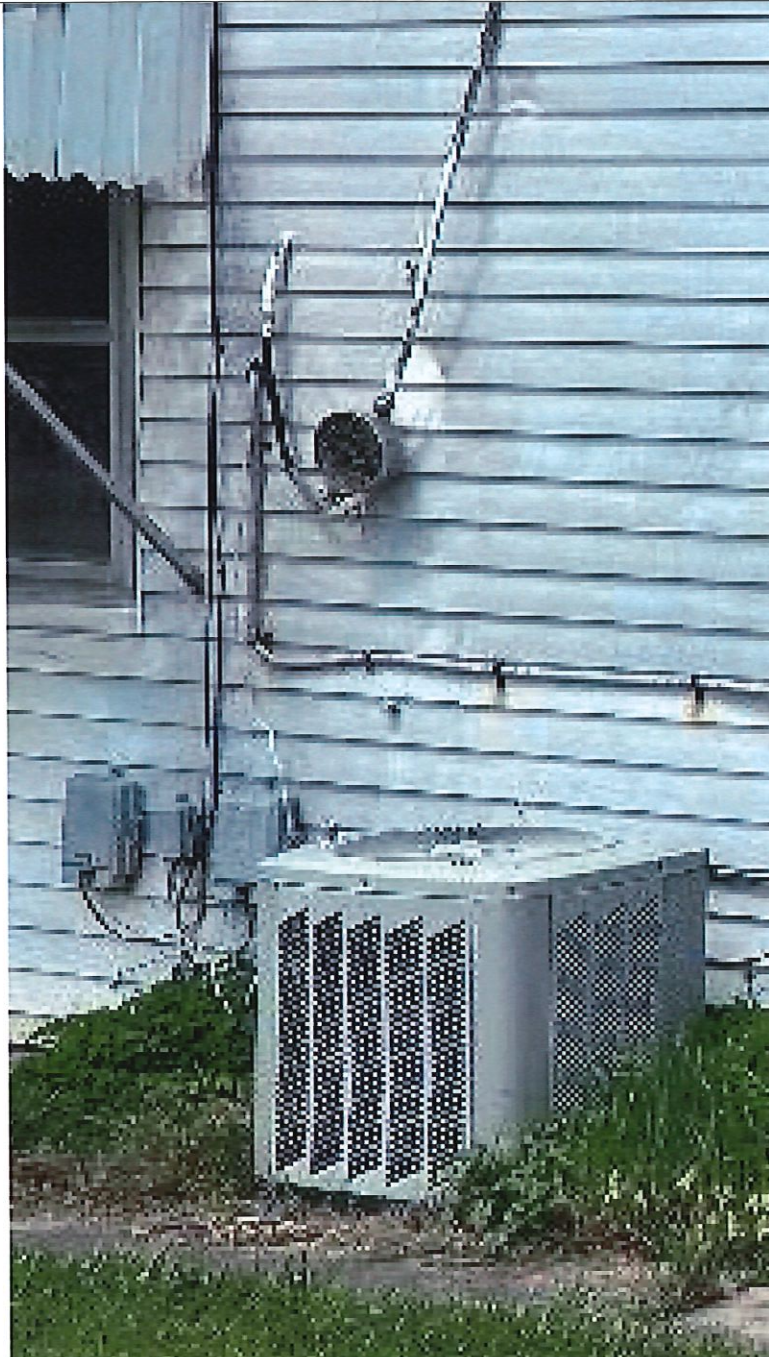
3. **Electrical Hazards:** The property has no power supply since the night of the incident, but there may still be residual electrical hazards present. Damaged electrical wiring, outlets and appliances within the structure pose a risk of electrical shock or fire if inadvertently activated or tampered with. Precautions should be taken to ensure that all electrical systems are properly deactivated and secured to prevent any potential incidents.

Exhibit D1.7 – Bravo Side (Disconnected Electric Meter)

4. **Electrical Safety:** Inspect and secure all electrical systems within the property to prevent the risk of electrical shock or fire hazards. Ensure that damaged wiring, outlets and appliances are properly deactivated and secured. Consider implementing additional safety measures, such as installing temporary barriers or signage to alert personnel to potential electrical hazards.
